Following periodical audit of the quality of its own product, Lovato Electric decided, after having noticed functional problems, to perform a recall campaign for the fuse holder of the series:

- FB01F
- FB01D
- FB01G

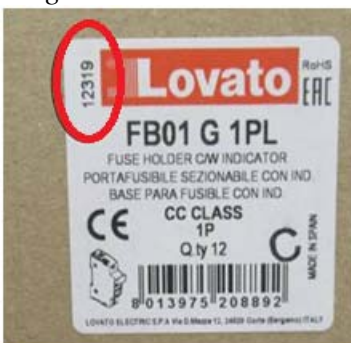
Image n.1 – Batch number on the product package

The batch number of the product object of the recall campaign is within the range 10117 and 10720. This means the production range of time within first week of January, 2017 and February, 14th, 2020 (first digit “1” is the revision index, while the following 4 digits are the week and year of production). The batch number can be read on the product package as on the product, as shown in the images below:

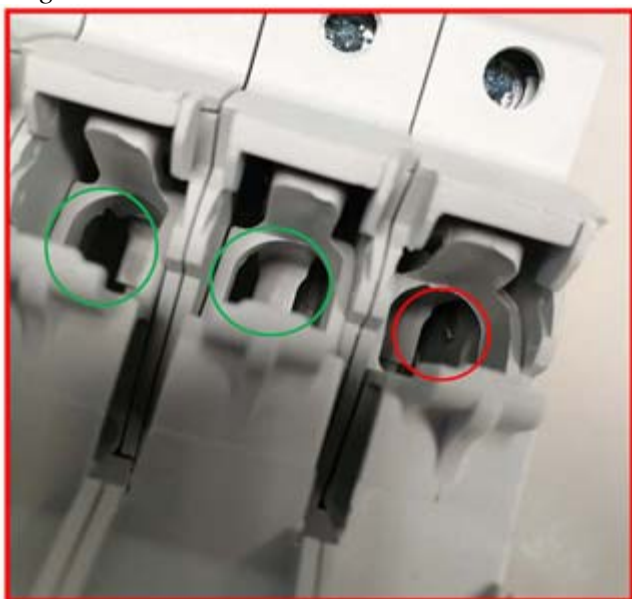
Image n.3

The anomaly found on the fuse holder object of the recall campaign is the wrong positioning of an internal component, as highlighted in the pictures below with the red boxes.

After our internal analysis , this wrong positioning has been found to be caused by a non conform assembling during the production process, caused by two components which were out of tolerance.

This wrong positioning of the internal component could increase the risk, according to Lovato Electric experience and judgment, to the following consequences:

- Overheating of the fuse holder;
- Risk to the operators if they open the fuse holder whilst operational, without the specific PPEs (dielectric gloves), touch a fuse still working (not fully interrupted), which is located within the fuse holder.

Even if, the defective percentage ratio has been found to be really low after the internal control, and likely assuming that products on the market may have a similar failure ratio, We invite you to check your warehouse as soon as you get this communication, in order to check if there may be products with batch number as indicated above.

In case that products with indicated batches number have been shipped to your customers, We invite you to advise them with all the details of this communication, so that they can segregate those products, preventing potential risk due to non conform products.

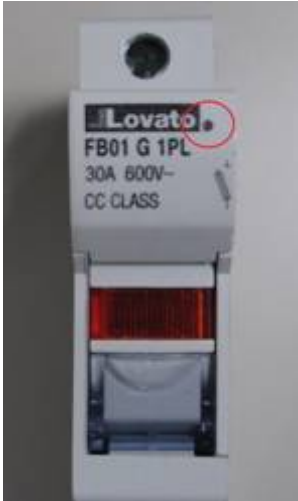
Image n.6

- Increased the visual inspection during the assembling process and the final test;
- Enhanced all its warehouses, by checking the products stocked, either in its Bergamo headquarter, as in all its foreign subsidiaries;
- Identified the checked products with a dot just on the side of Lovato Electric brand, as shown in the following image.
